Appendix F
Stream Bank Erosion Methods and Results

Sediment TMDL Methods and Results

Stream bank Erosion Inventory

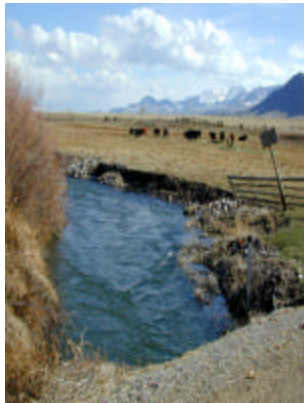
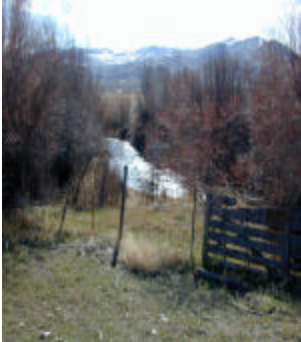
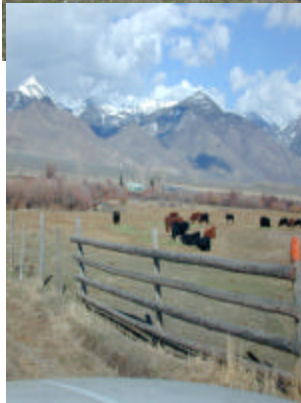
Flow a contributing factor?: No, good access to well vegetated flood plain over most of reach.

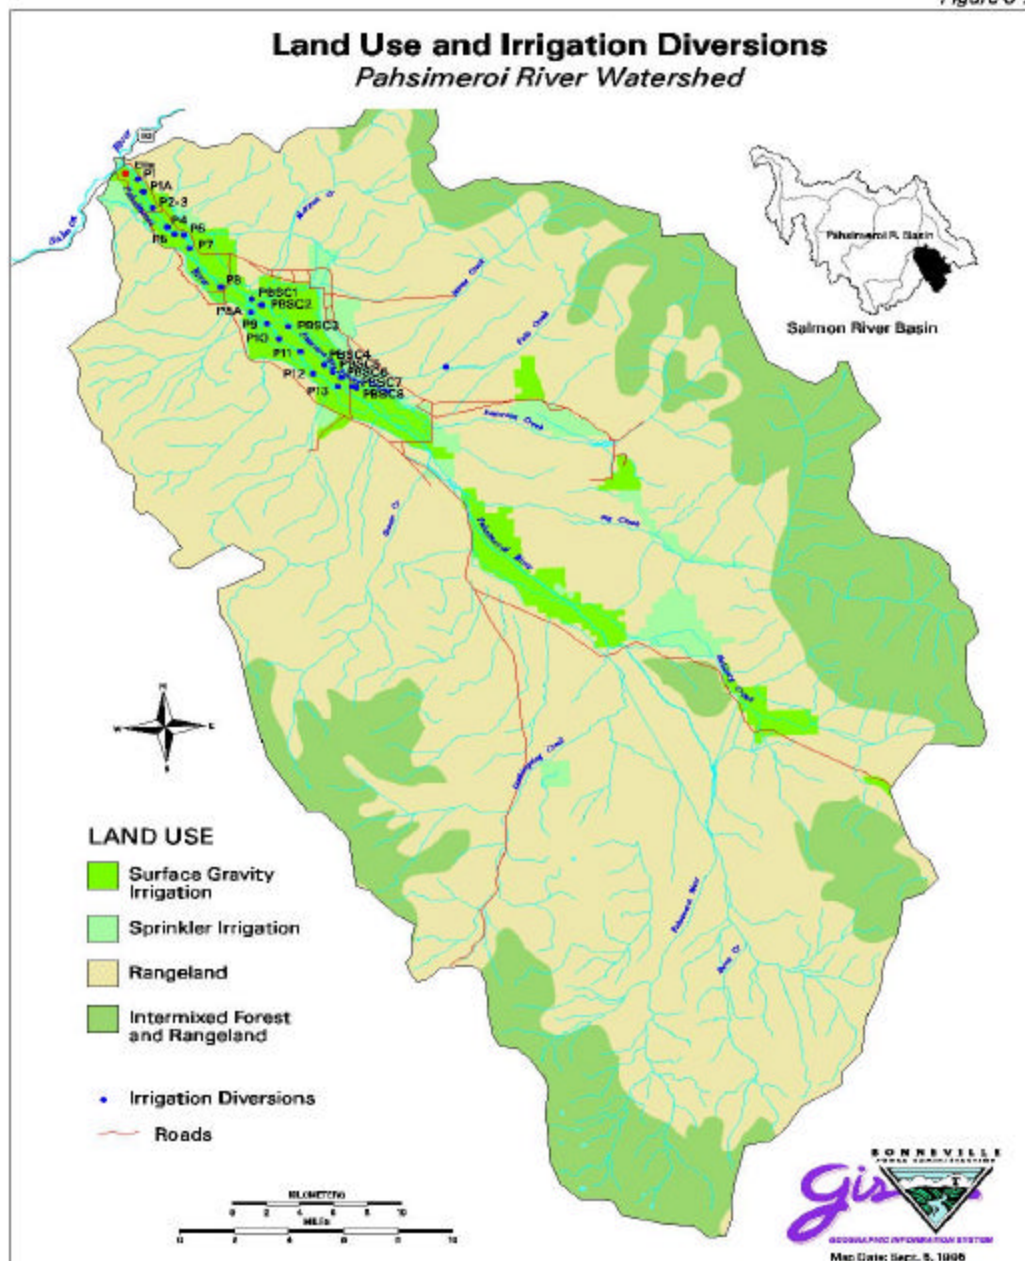
Figure 5-2

Appendix G
Bonneville Power Administration
Land Use and Irrigation Diversions Map for the Pahsimeroi Subbasin
